Indicative fire test

332065/A

Hoody Speaker Hoods Ltd

Date: 12th November 2013

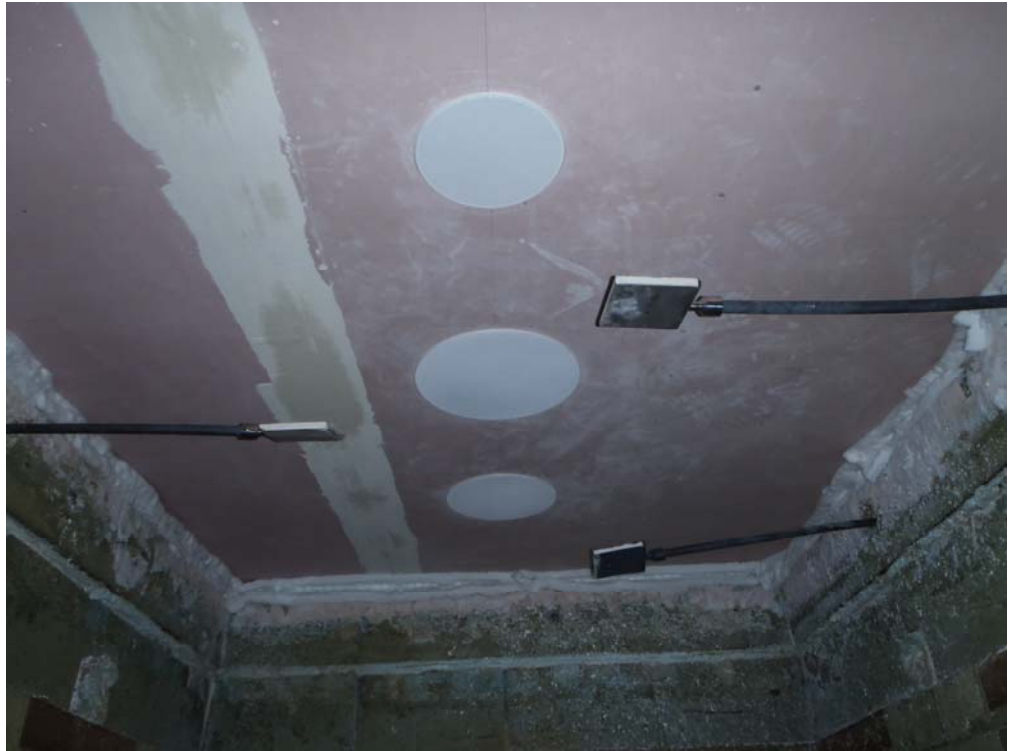
The exposed face of the ceiling prior to the test.

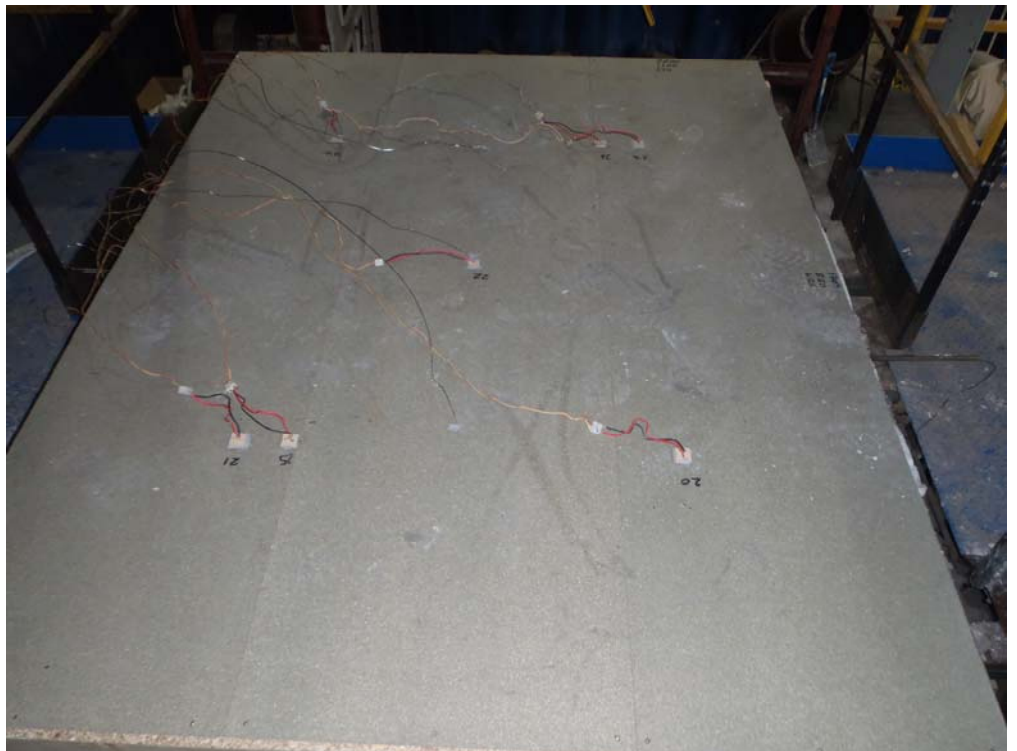
The unexposed face of the ceiling prior to the test.

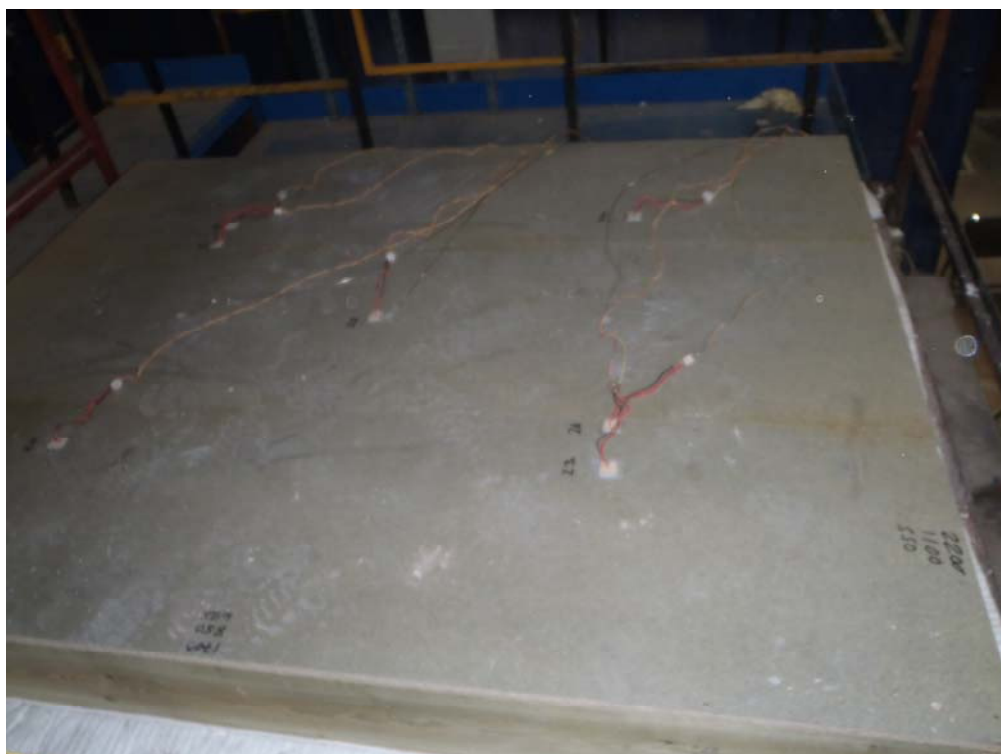
The unexposed face of the ceiling after a test duration of 30 minutes

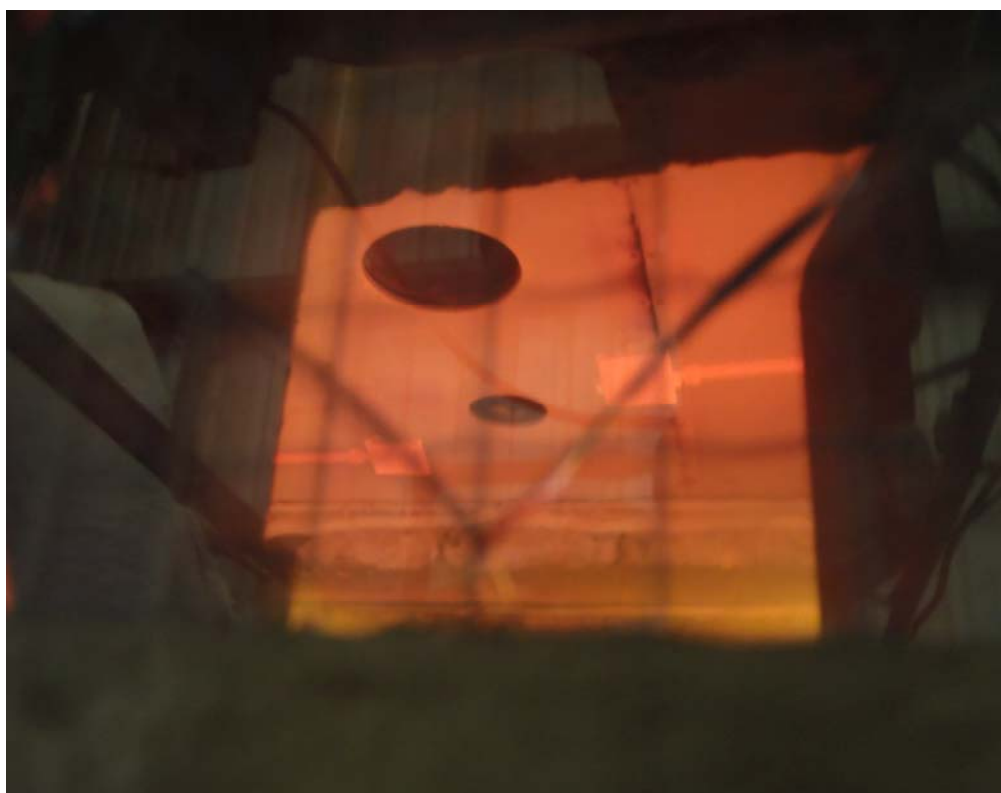
The exposed face of the ceiling after a test duration of 30 minutes

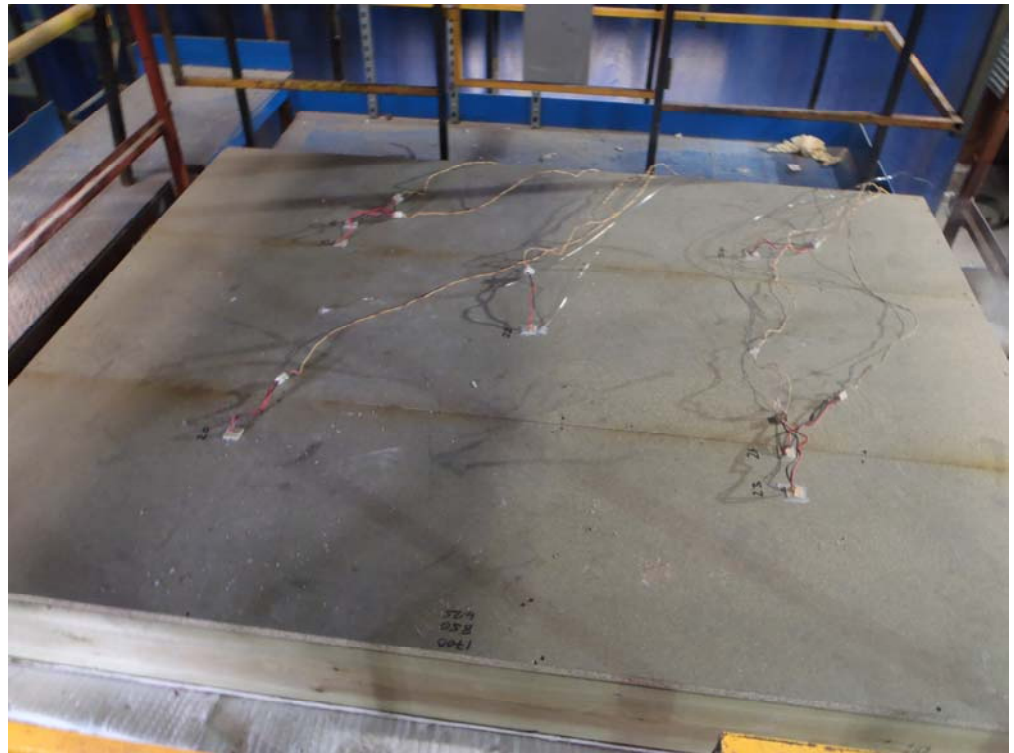
The unexposed face of the ceiling after a test duration of 60 minutes

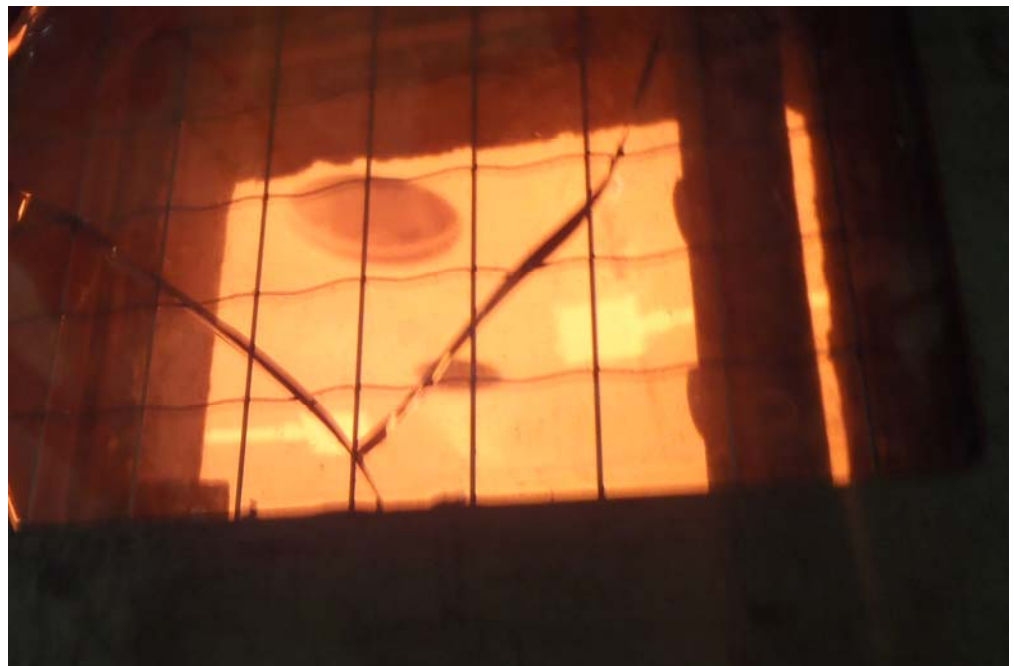
58	40	Viewed from the exposed face, a large section of the first layer of ceiling board has dropped downwards by approximately 30 – 35 mm as it begins to detach from the ceiling along the joint.
62	10	Smoke release from the joints within the timber floor has increased slightly. Discolouration has become more evident at the same location.
64	30	Viewed from the exposed face, flames issue from the circular openings within the ceiling. The first layer of the ceiling board has dropped down further along the joint now by approximately 50 mm.
71	30	Smoke release from the joints within the timber deck has increased further.
72	10	Viewed from the exposed face, a large section of the first layer of ceiling board continued to pull away from the ceiling now by approximately 150 – 200 mm.
73	10	A large section of the first layer of ceiling board has detached and fallen into the furnace chamber.
75	00	Smoke release has increased further along the timber deck joints.

The exposed face of the ceiling after a test duration of 60 minutes

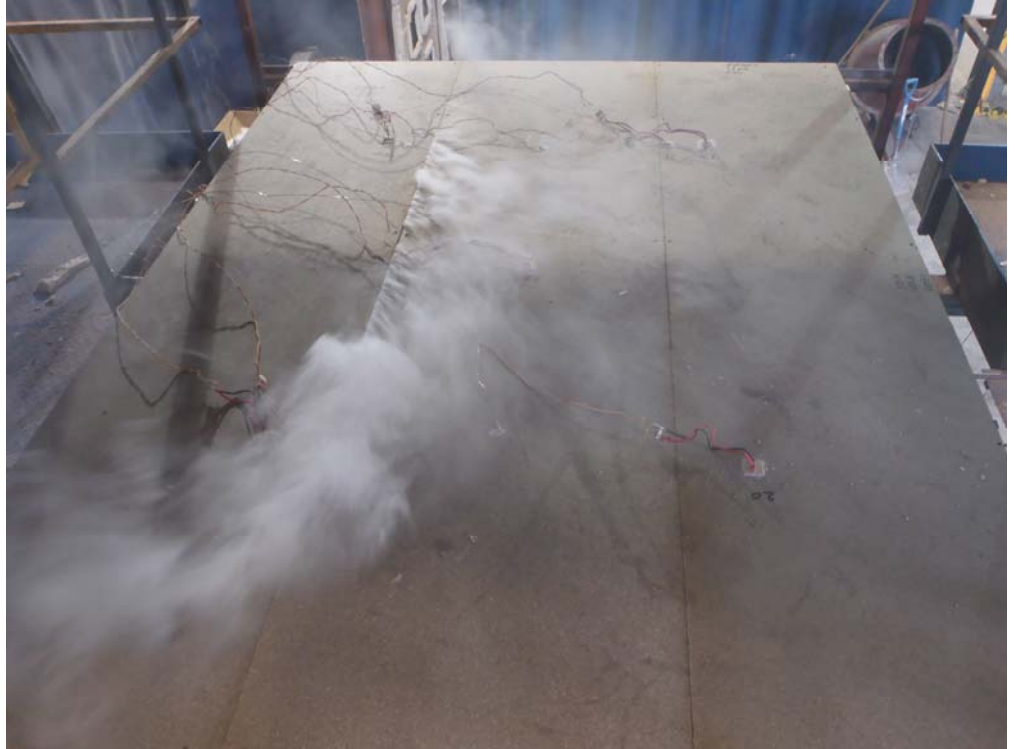
The unexposed face of the ceiling after a test duration of 90 minutes

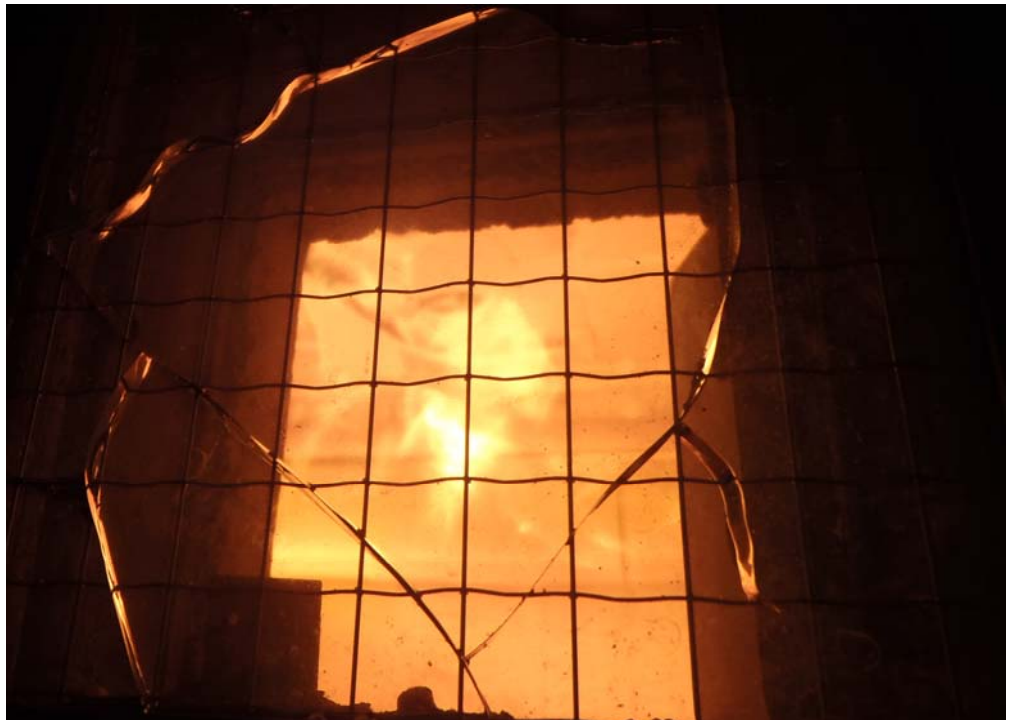
78	55	A cotton pad is applied at the mid span of a timber deck joint but fails to ignite.
83	20	Viewed from the exposed face, large amounts of flaming issue from the circular apertures within the ceiling.

The exposed face of the ceiling after a test duration of 90 minutes

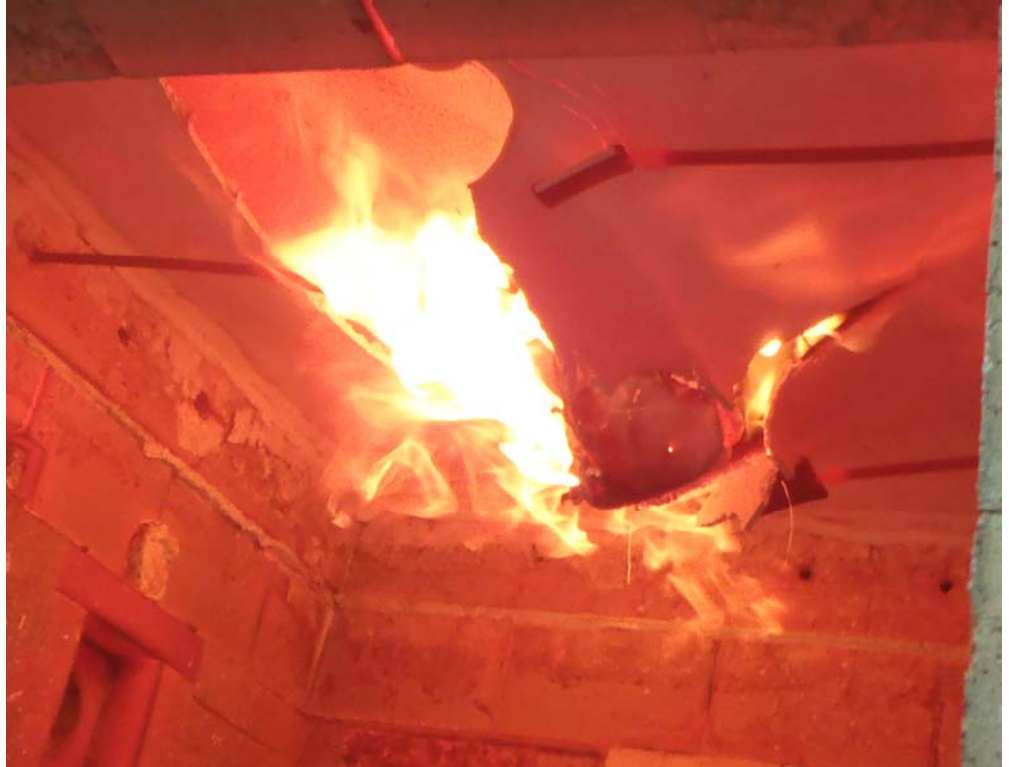
| 89 | 50 | A large section of the second layer of board begins to drop downwards at the approximate centre of the ceiling. |

**The exposed face
of the ceiling
immediately after
the test**
